## PRELIMINARY REPORT

Aircraft	Piper PA-28RT-201T / YU-DZZ
Date and time	27.06.2019 / 08:58 LT (06:58 UTC)
Operator	STS AVIACIJA d.o.o.
Type of Flight	Aerial Work
Perssons on board	The pilot and the operator of vaccine scattering equipment
Victims	N/A
Damage to the aircraft	The aircraft was slightly damaged
Occurrence location	The runway of the G. V. Bibescu - Strejnic Aerodrome

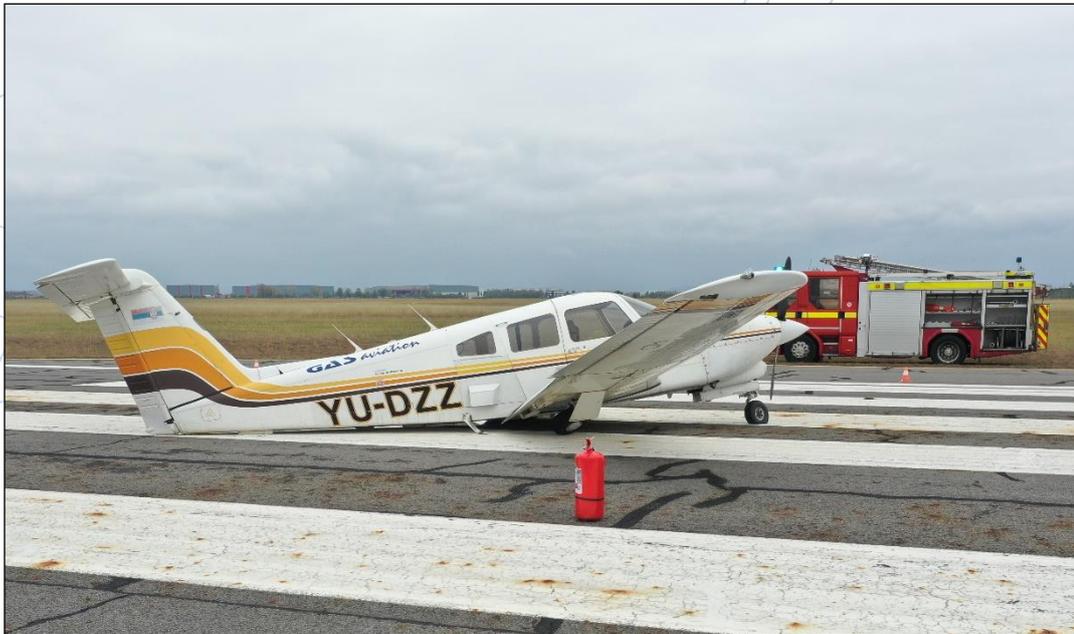
After receiving confirmation from the control tower that the landing gear is down, the pilot of the aircraft made the decision to land on runway 08 at a reduced speed (approximately 83-84 knots). After contact with the runway, from the moment the brake started to apply, the landing gear began to retract slightly, until the moment when the ventral part of the aircraft's fuselage came into contact with the runway. From the

moment the fuselage came into contact with the runway, the aircraft rolled for about 250 m and then stopped at the end of the runway.

Fig. 1 – The aircraft in its final position

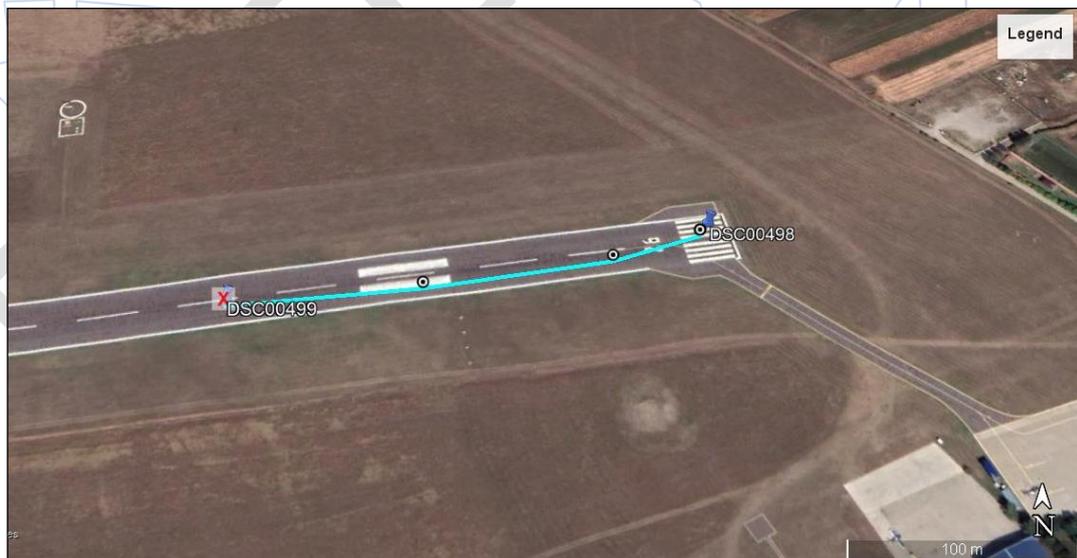
Fig. 2 – The trajectory of the aircraft after the fuselage contacted the runway

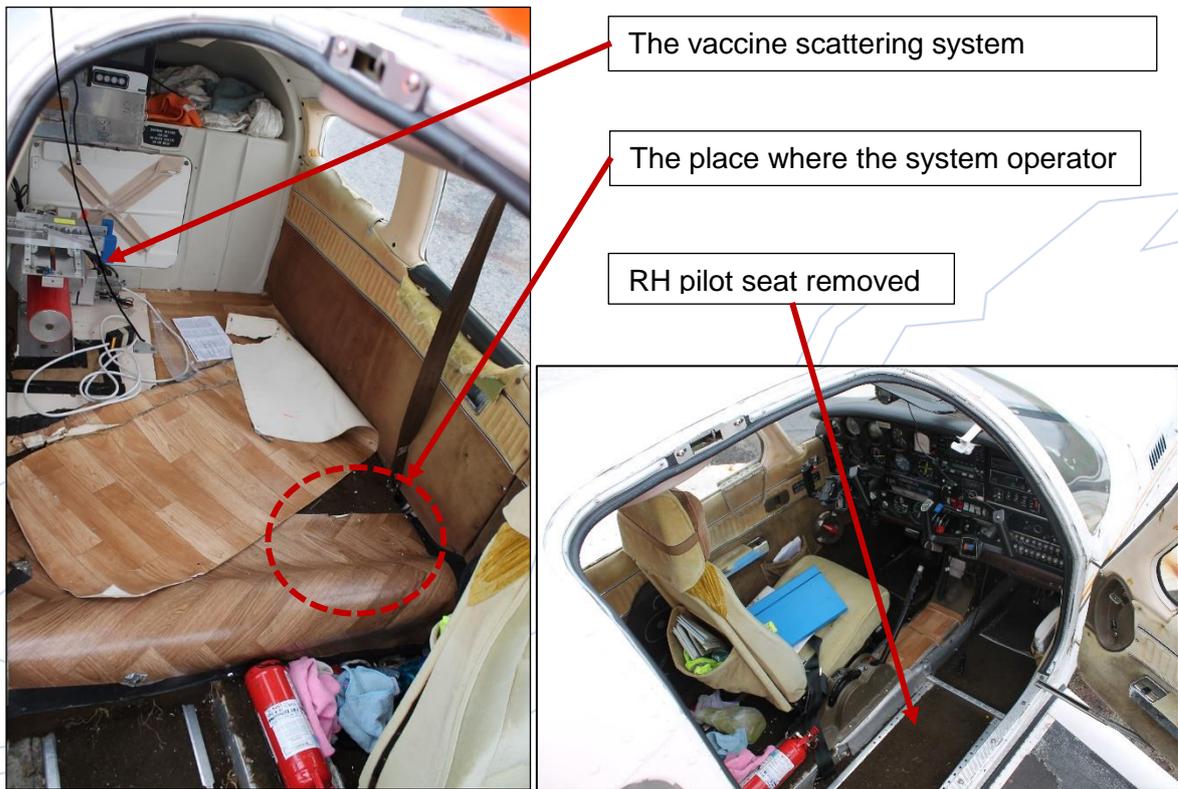
- the last row of seats removed;
- the right-hand pilot seat removed, the vaccine bait boxes being stored in its place;
- the vaccine scattering system installed in the luggage compartment from behind;
- the operator of the system sits on the floor behind the pilot, not using a seat belt system.

Fig. 3 – The last row of seats removed, the vaccine scattering system and the place in the cabin of the system operator

The aircraft registered YU-DZZ has a different configuration than the one in its documents, so that during a mission, on board the aircraft are the pilot of the aircraft occupying the left hand pilot seat and the operator of the vaccine scattering system sitting on the floor. In this configuration, the safety of the operator and the flight are endangered during the operation of the aircraft.
